# Manhole Inspection Summary

Manhole # S41A2\_004MH

Insp Date: **12/6/07 9:22 AM**

**Location** Address: **3700 9th St**

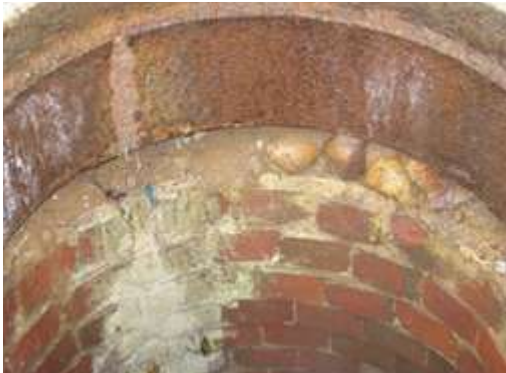
Defect 1

Condition: ☐ Sound ☒ **Cracked** ☐ Root Intrusion ☐ Loose Brick ☐ Deteriorated

Infiltration: ☐ None ☐ Joint ☒ **Cracks** ☐ Mortar ☐ Roots ☐ Wall

Mortar/Cracks

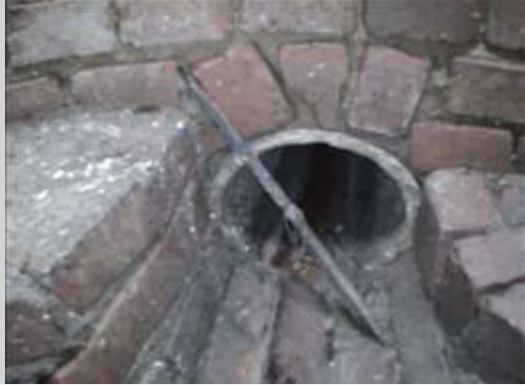
12 O'Clock Outflow

8 in. Circular Gravity Sewer  
Pipe Out @ 12 O'Clock

Pipe Height: **9.6** (in.) Rod and Bar (Angled)  
Pipe Material: **Clay** ☐ Pipe Lined  
Invert Depth: **8.79** (ft.) Flow Characteristics: **Fast**  
Deposits: ☒ None ☐ Mud ☐ Sludge ☐ Debris ☐ Grease  
Silt Depth: (in.) Deposits Extent:  
Infiltration: **None** Pipe Seal Cond: **Sound**

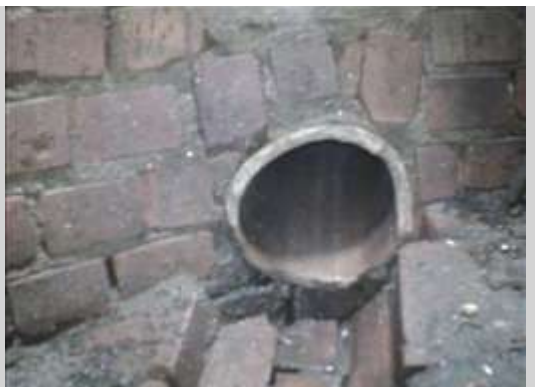
2 O'Clock Inflow

6 in. Circular Service Sewer  
Pipe In @ 2 O'Clock

Pipe Height: **7.2** (in.) Rod and Bar (Angled)  
Pipe Material: **Clay** ☐ Pipe Lined  
Invert Depth: **7.88** (ft.) Flow Characteristics: **None**  
Deposits: ☒ None ☐ Mud ☐ Sludge ☐ Debris ☐ Grease  
Silt Depth: (in.) Deposits Extent:  
Infiltration: **None** Pipe Seal Cond: **Sound**

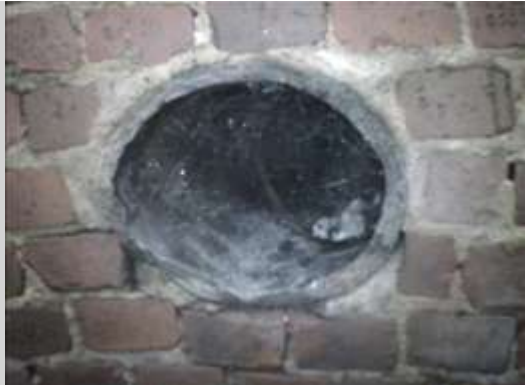
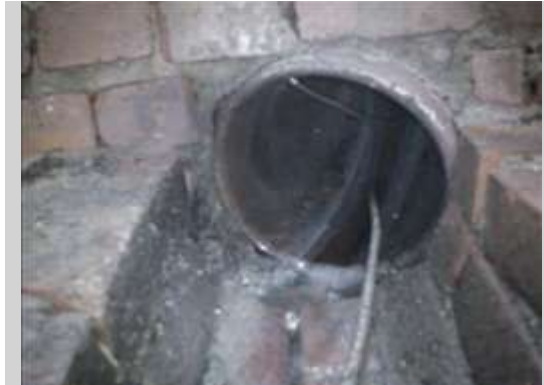
5 O'Clock Inflow

Pipe Height: **8.4** (in.) Rod and Bar (Angled)

Drop: **Outside** Rod and Bar  
Angled: **Yes** Reading: **7.09** (ft.)  
Inv Depth: **8.09** (ft.)  
Drop Condition: **Open**

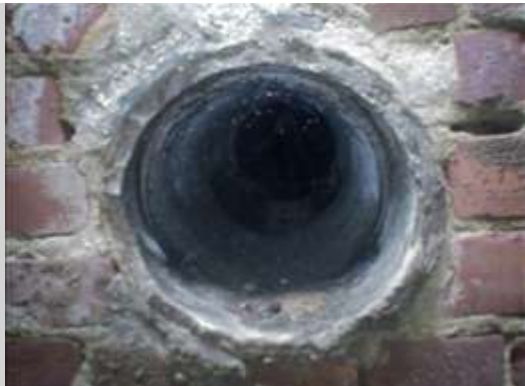
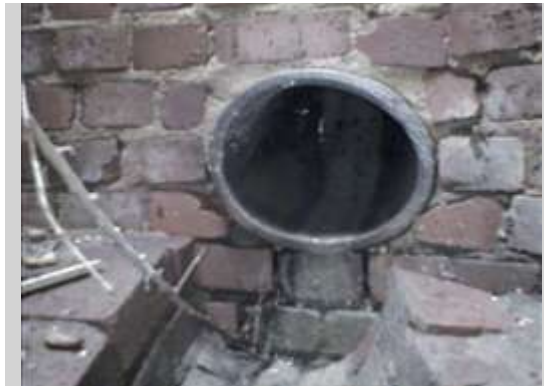
9 O'Clock Inflow

Pipe Height: **9.6** (in.) Rod and Bar (Angled)

Drop: **Outside** Rod and Bar  
Angled: **Yes** Reading: **6.67** (ft.)  
Inv Depth: **7.67** (ft.)  
Drop Condition: **Open**
